Integrated Ridge-to-Reef Monitoring Framework: Tracking Reduction of Land-Based Pollutants and Their Impact on Caribbean Near-Shore Ecosystems in Culebra, Puerto Rico

YASIEL A. FIGUEROA SÁNCHEZ (M.SC.)

PROTECTORES DE CUENCAS (NGO)

ICRI WEBINAR SERIES: THE IMPACTS OF LAND-BASED SOURCES OF
POLLUTION ON CORAL REEFS

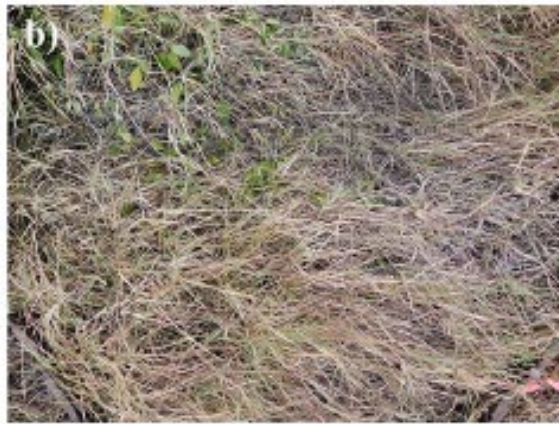
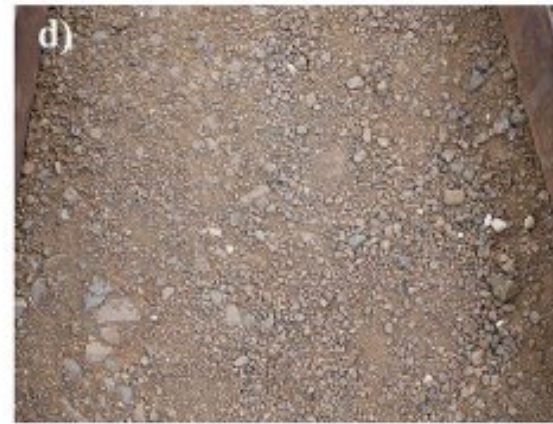
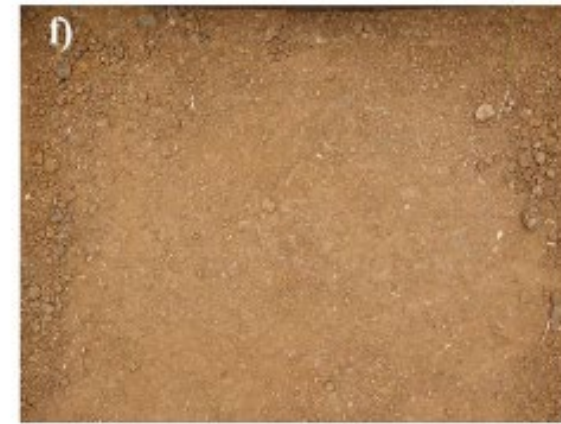
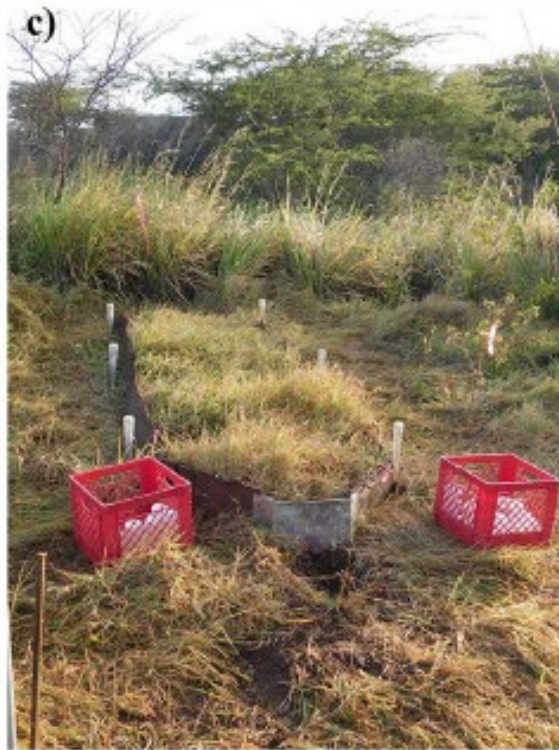
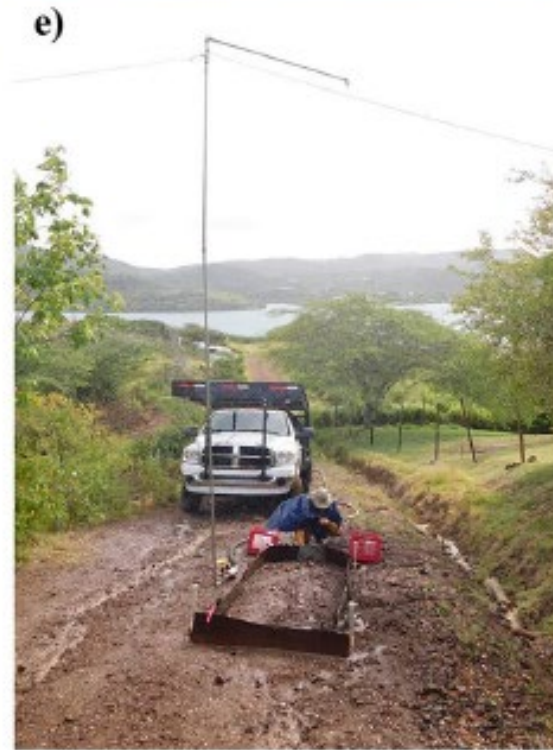
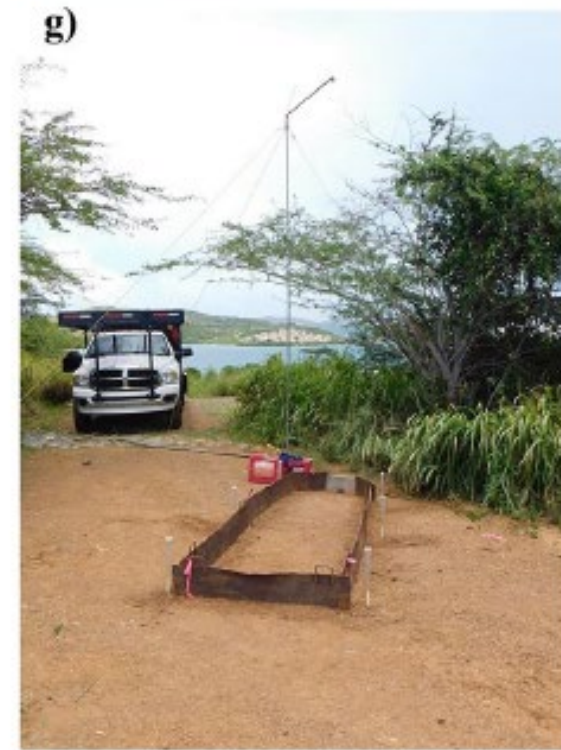
Rainfall Simulation Experiments

- Experiments were conducted using a standardized rainfall simulator design (Luk et al. 1986) and bounded plots delimited by ~ 2.5-cm thick iron plates vertically pounded into the soil.
- Rainfall was measured every 5 min.
- Experimental rainfall intensities were in the 30 to 70 mm/hr range (48 mm/hr average), which represent 1-h rain rates expected to occur in Culebra between once a year to once every 25 years, respectively (every 5 years for the average value) (Bonnin et al. 2006).
- Runoff was measured every minute.
- Sediment concentration samples were collected every 5 minutes.

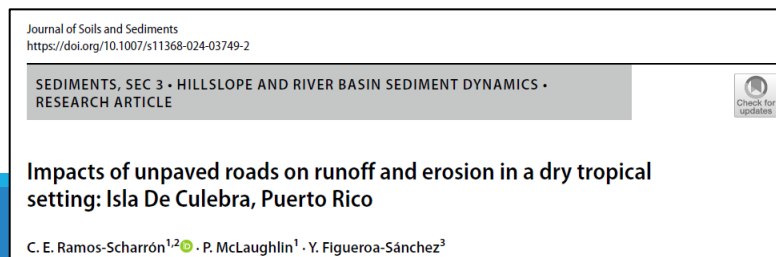
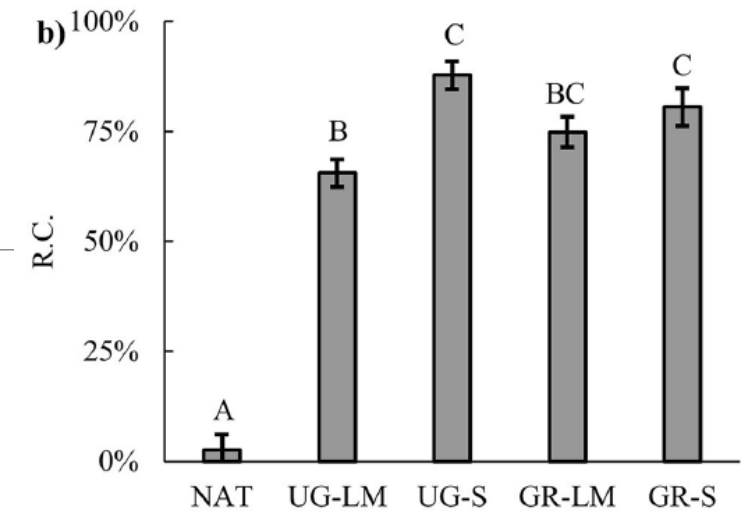
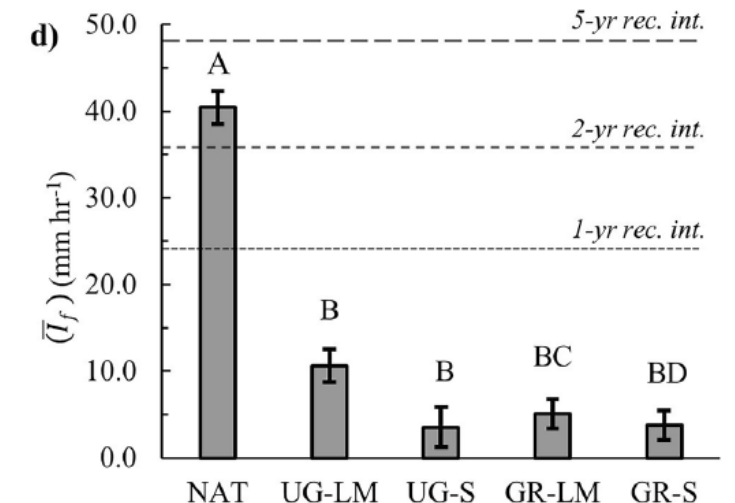
Empirical documentation of the impact of unpaved roads on runoff and erosion

On average ~ 70 min and ~ 65 mm (2.5 inches) of rain at a rate of ~ 55 mm/hr (2.2 in/hr) were needed to generate any runoff from natural hillslopes.

In contrast, road runoff began 2–4 min into the experiment and after only ~ 2 mm of rainfall at rain intensities of 35–50 mm/hr (1.4-1.9 mm/hr) range.

The modeled infiltration rate of natural hillslopes ranged from 55.8 mm/hr (2.2 in/hr) during the first 175 minutes of rainfall to 33.5 mm/hr after 225 minutes of rainfall.

In contrast to natural hillslopes, infiltration rates for roads were 35–54 mm/hr early during the rainfall simulations and dropped to 3.5–10.6 mm/hr during the last 15 min of the experiments.

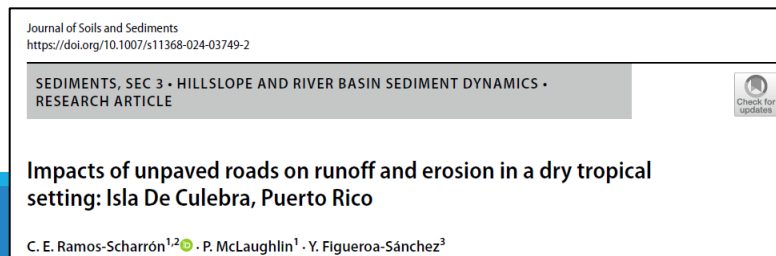
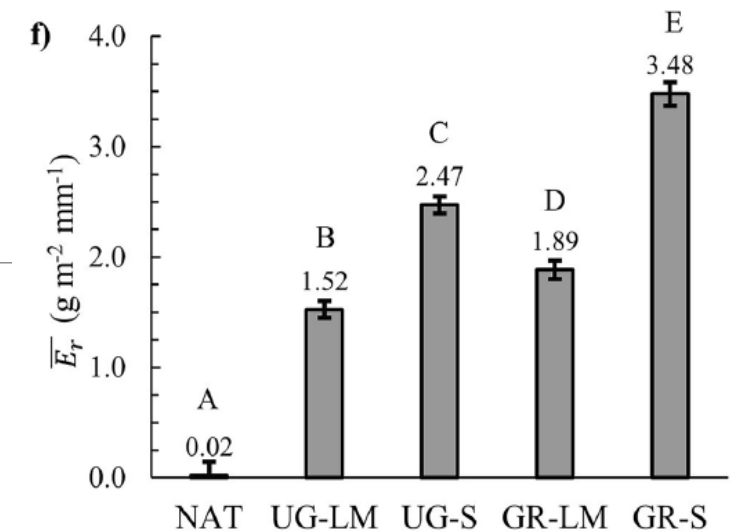
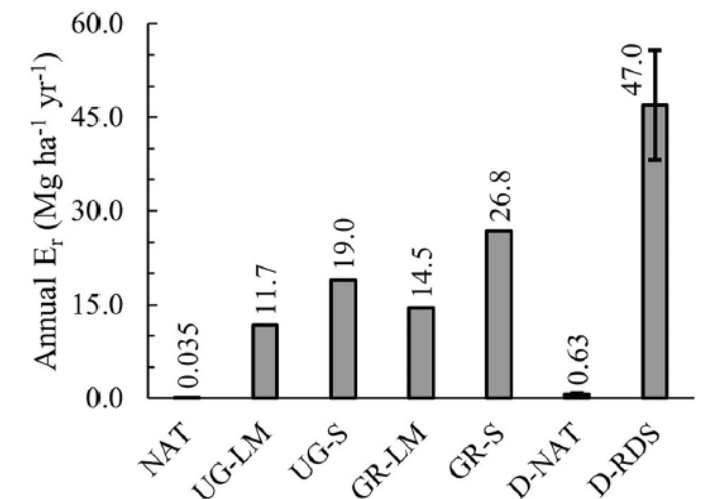
Empirical documentation of the impact of unpaved roads on runoff and erosion

➤ Annualized road erosion rates in Culebra are between 330 and 760 times greater than natural erosion ($\sim 0.035 \text{ Mg ha}^{-1} \text{ yr}^{-1}$).

➤ These are on the midrange of values reported for similar dry tropical areas in the Caribbean (i.e., St. John-USVI and La Parguera and Cabo Rojo in Southwest PR) which average $\sim 47 \text{ Mg ha}^{-1} \text{ yr}^{-1}$ (Ramos Scharrón et al. 2023), yet individually have reached up to $580 \text{ Mg ha}^{-1} \text{ yr}^{-1}$ (Ramos Scharrón and MacDonald 2007)

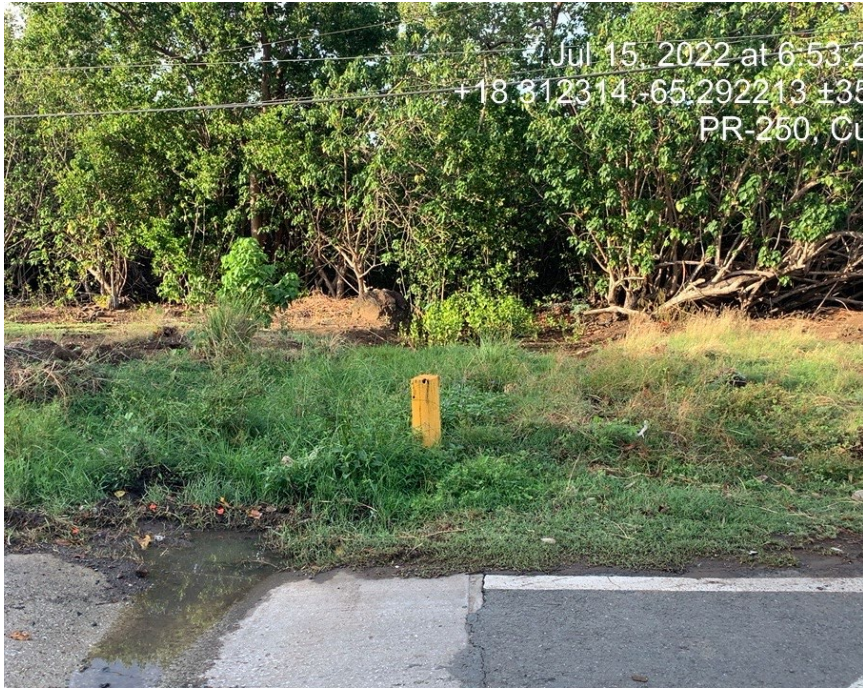
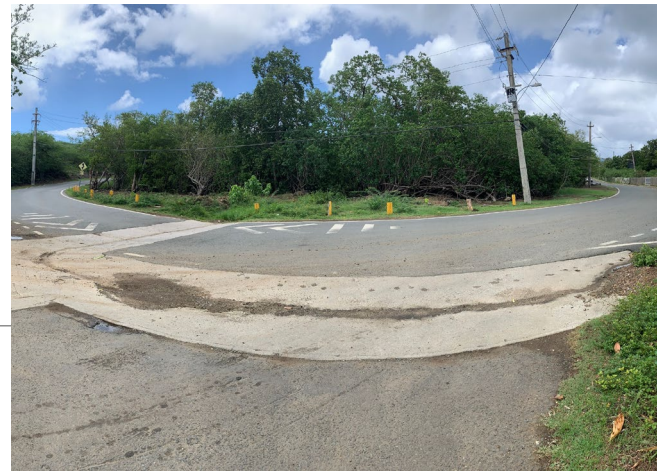
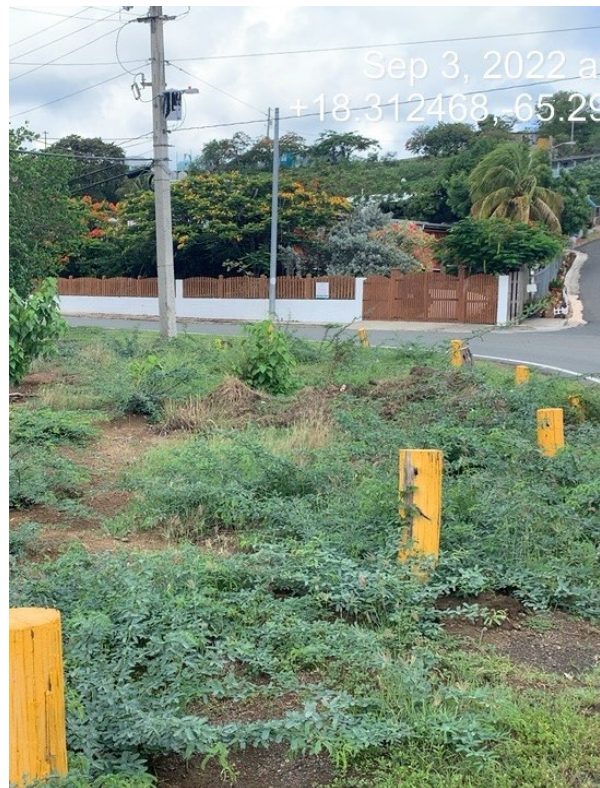
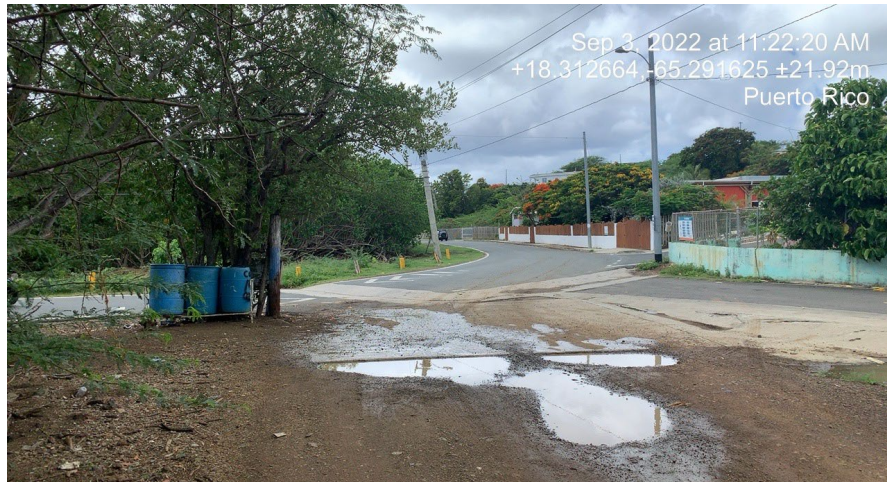
Jardín Pluvial PR-250 Culebra

➤ Before Implementation

➤ Common drainage point of close to 1.3 miles of unpaved roads within the Coronel watershed.

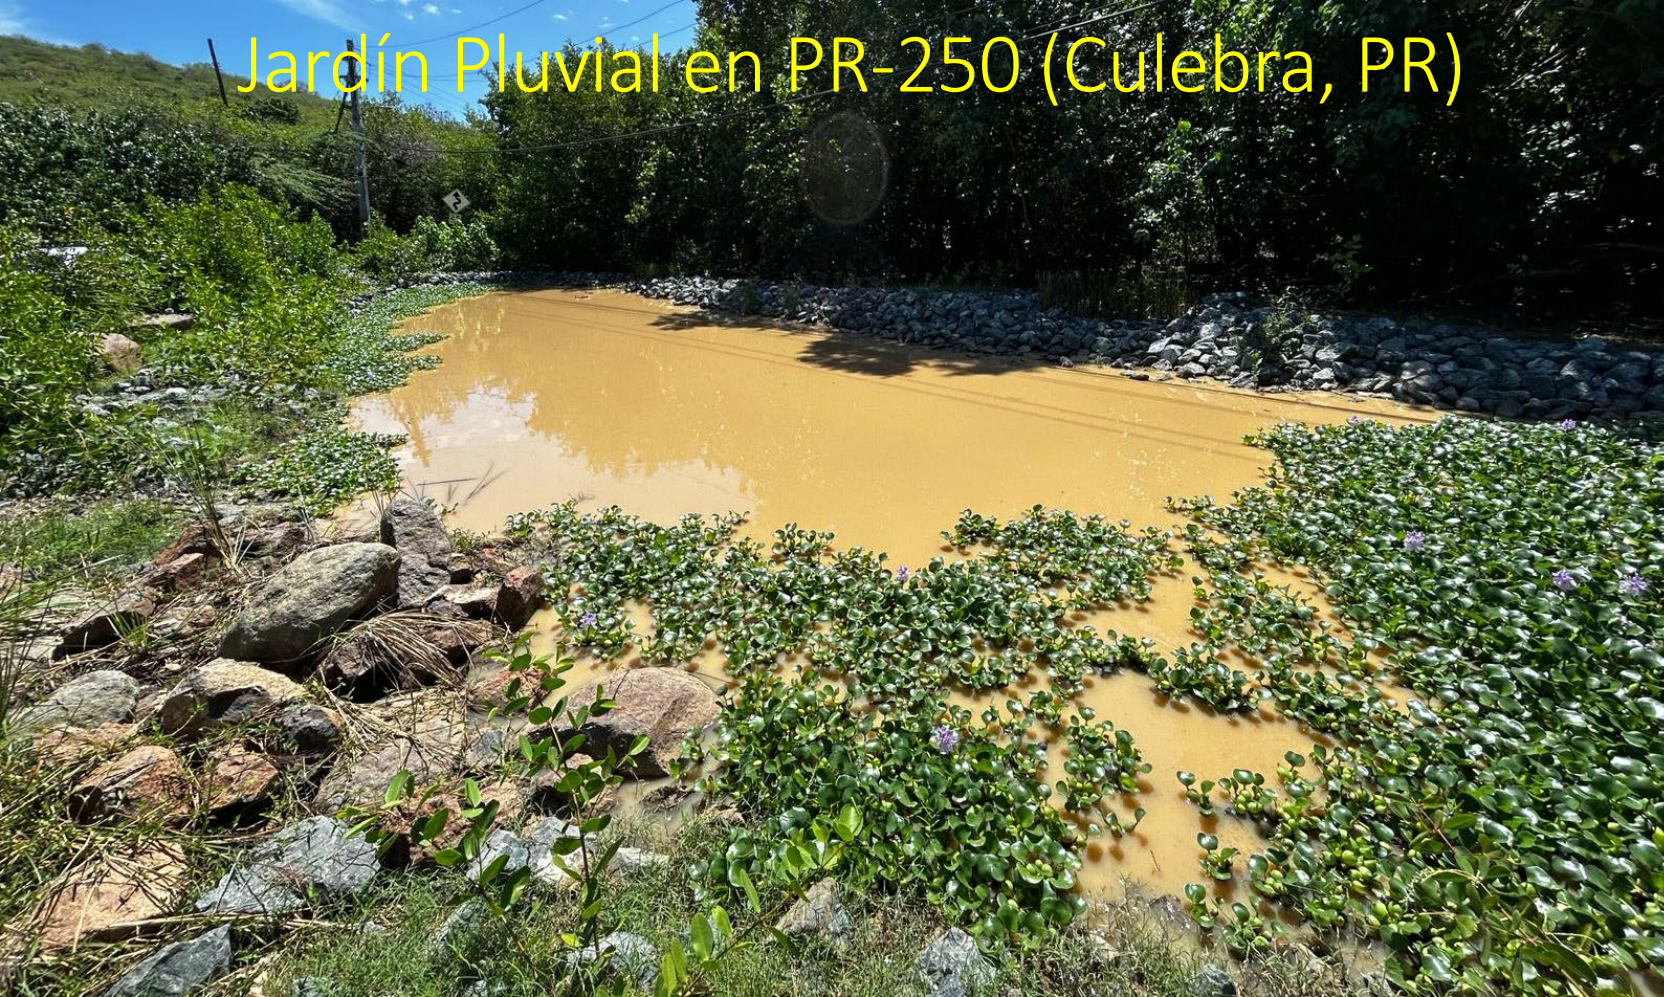
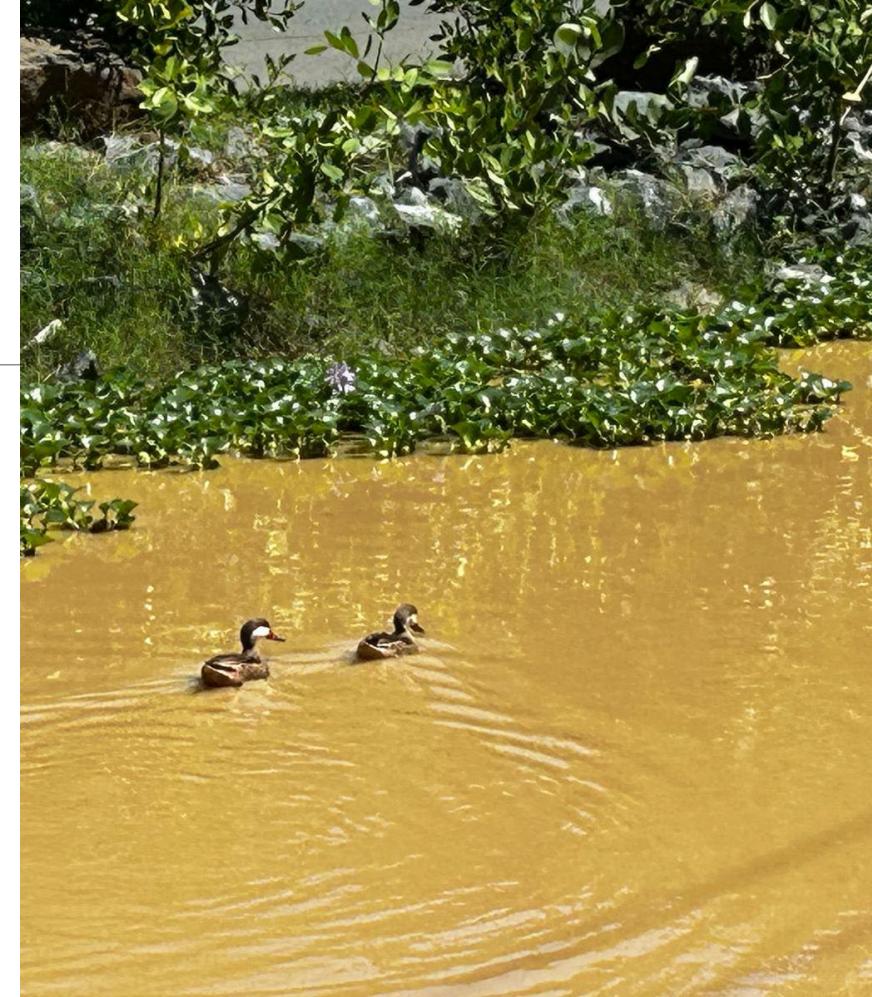
Jardín Pluvial en PR-250 (Culebra, PR)

- Imágenes del 28 de febrero de 2024.
- Luego de 1.24 pulgadas de lluvia en 24 horas aprox.
- Estos eventos representan el 42% de la lluvia registrada en febrero.
- Previo a esto no hubo evento de lluvia significativo desde el 6-7 de febrero.

Evento	Cantidad de lluvia (Pulgadas)	Duración (horas)	Intensidad Max (pulg/hr)
Feb 26 (6:15 pm)	0.45	3.75	0.3
Feb 27 (7:00 am)	0.07	1.75	0.06
Feb 27 (1:30 pm)	0.53	1.75	0.41
Feb 27 (5:30 pm)	0.19	1.75	0.18
Total de lluvia	1.24 pulgadas

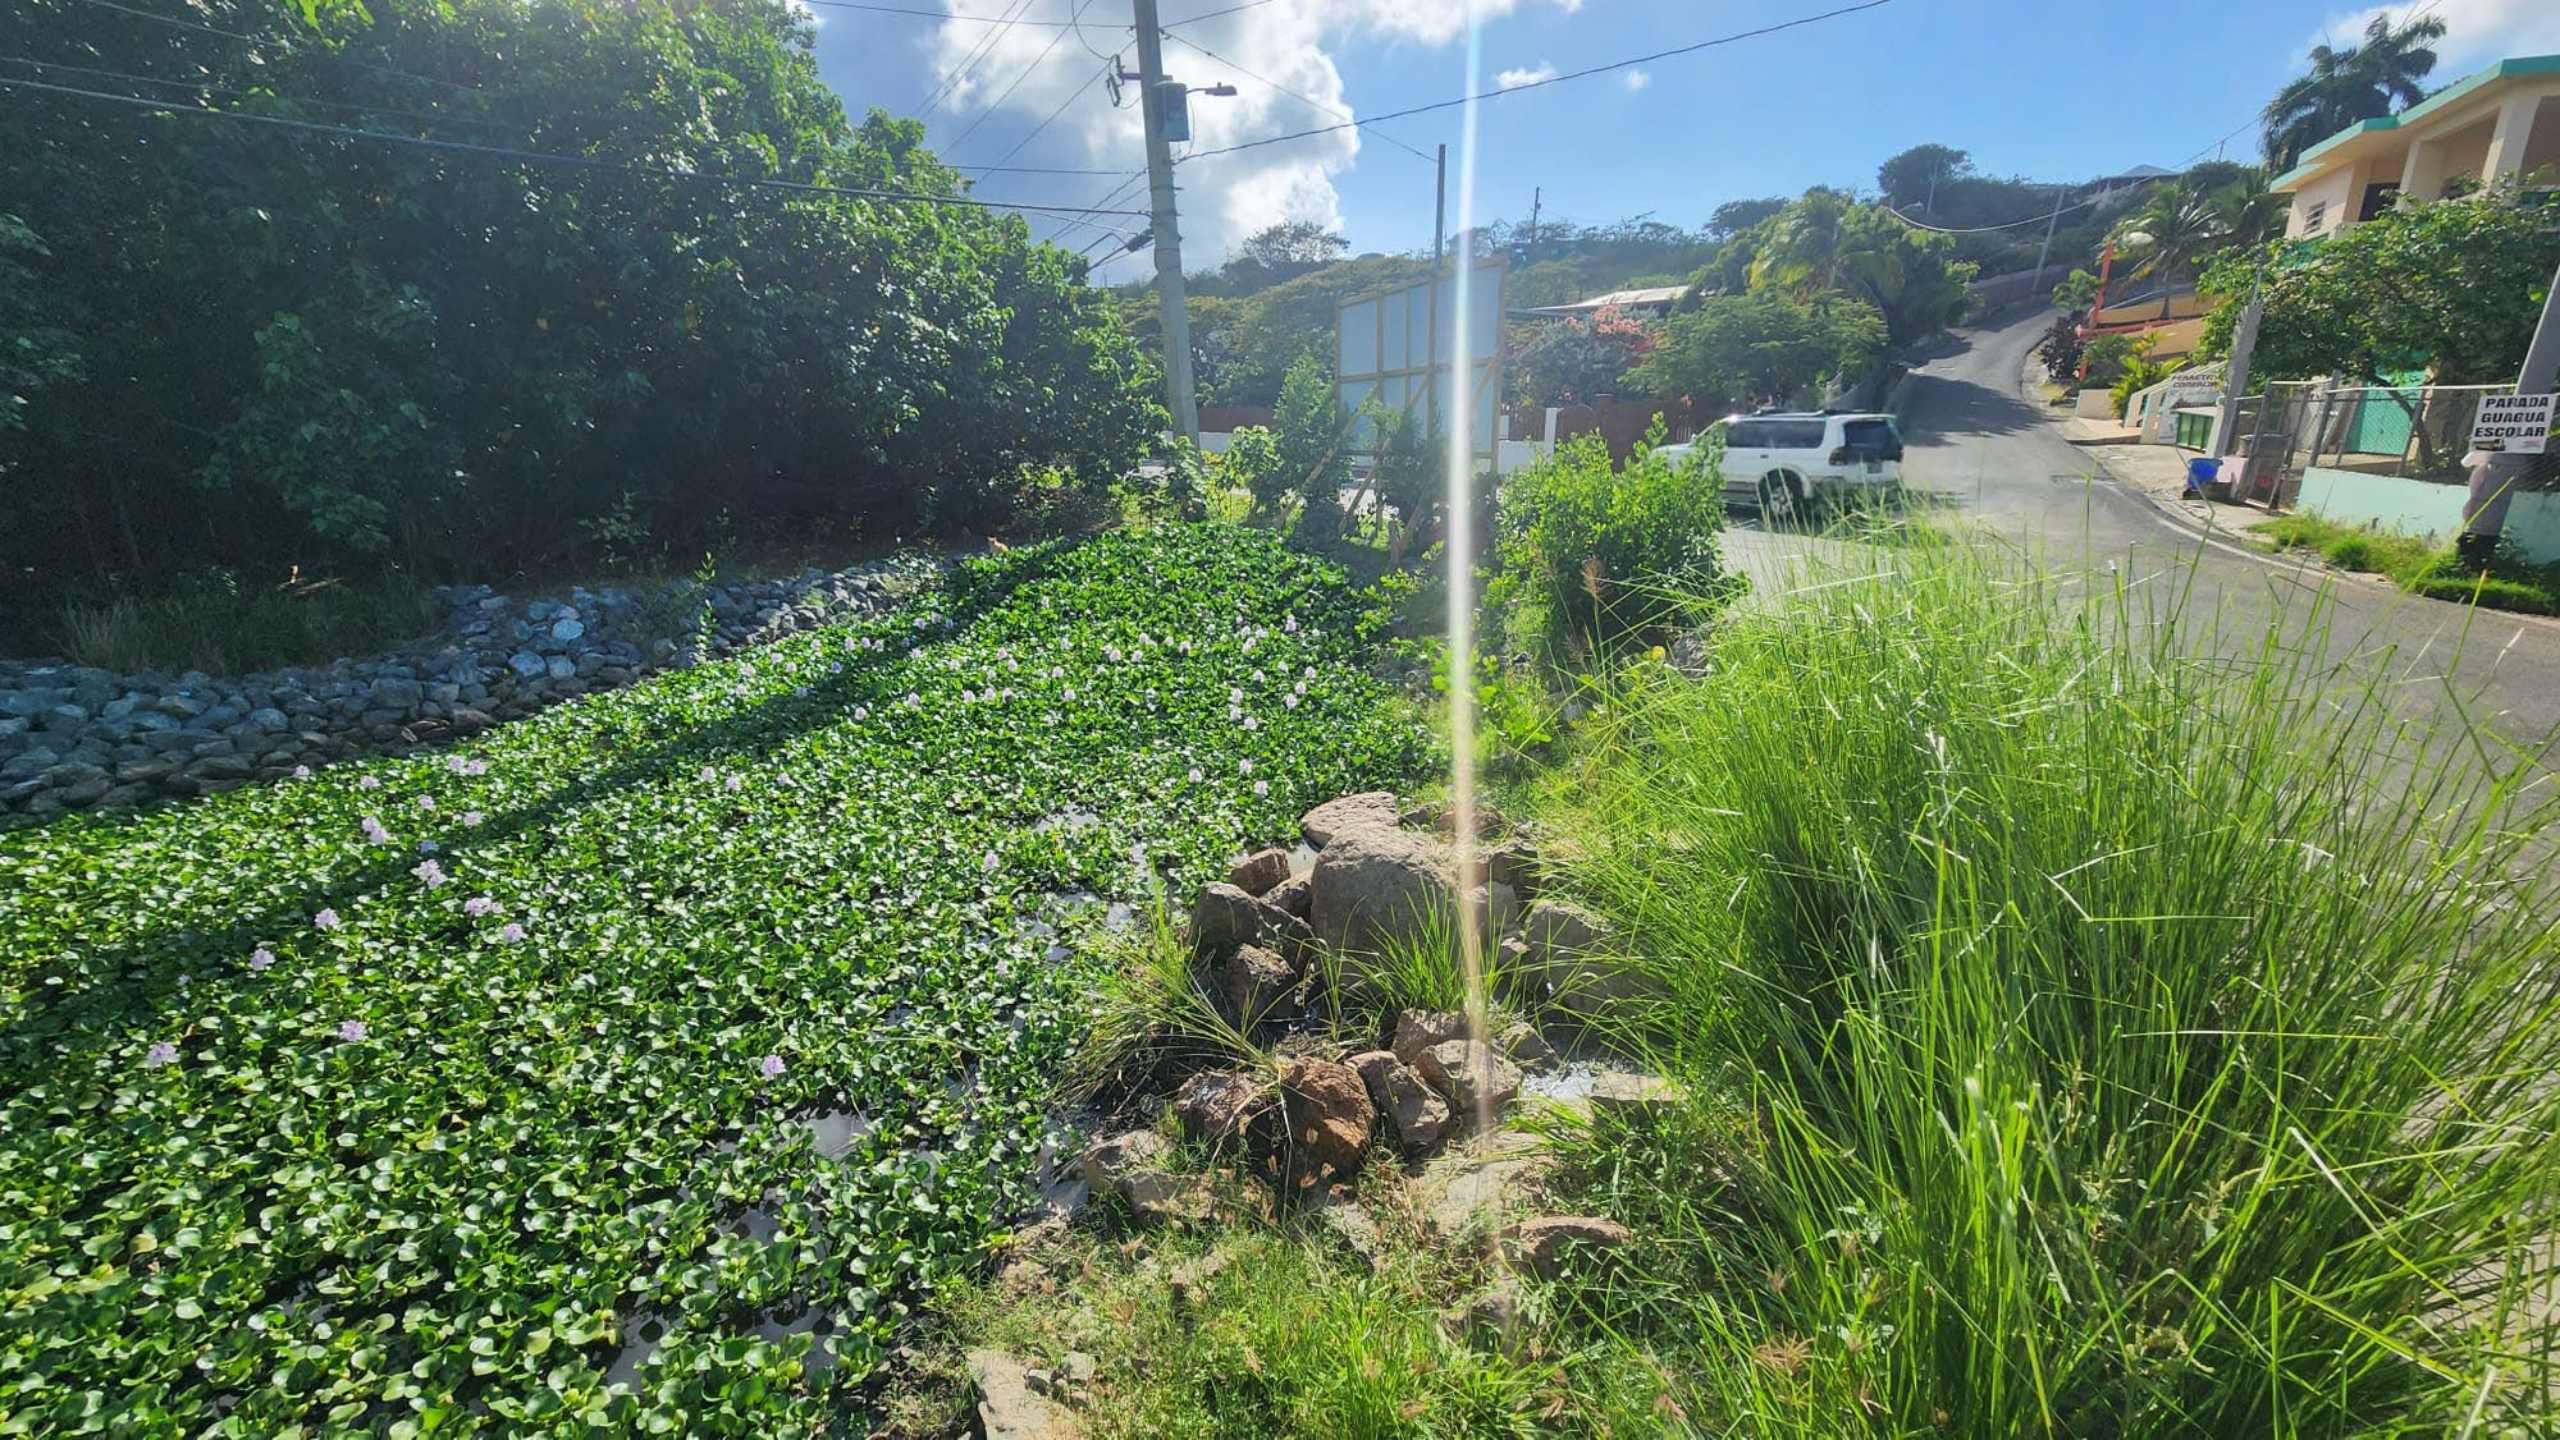
PARADA
GUAGUA
ESCOLAR

Coronel Camino Cofresí

➤ Pre-Implementation
images

➤ Drains to main rain
garden in PR-250

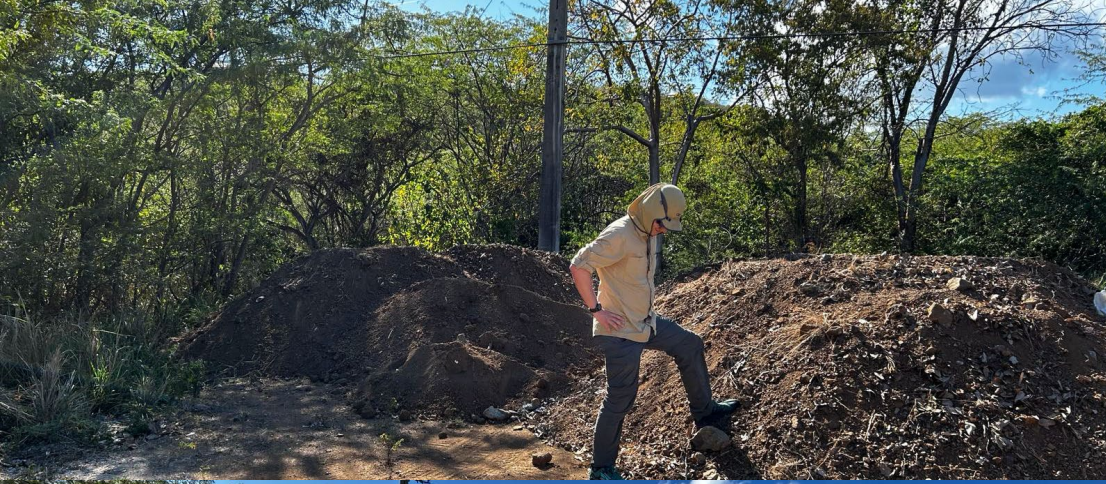
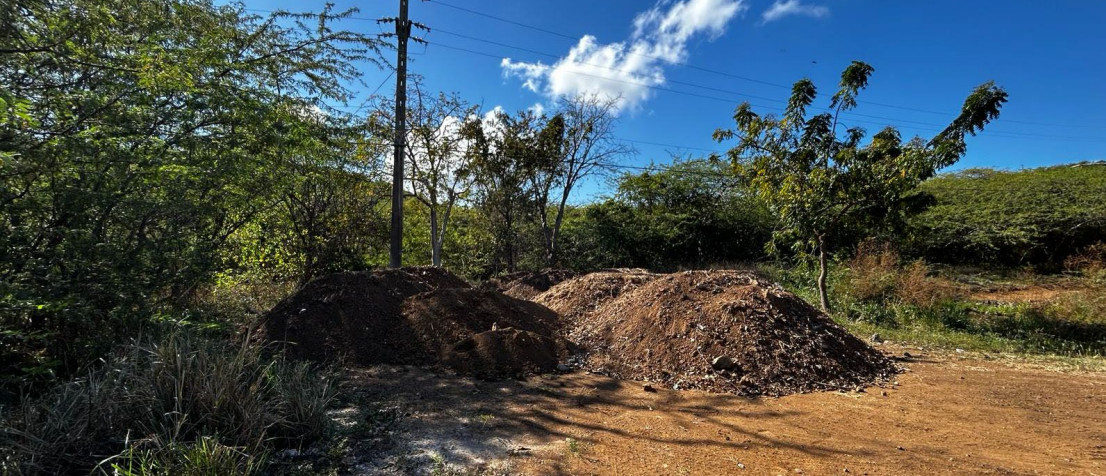
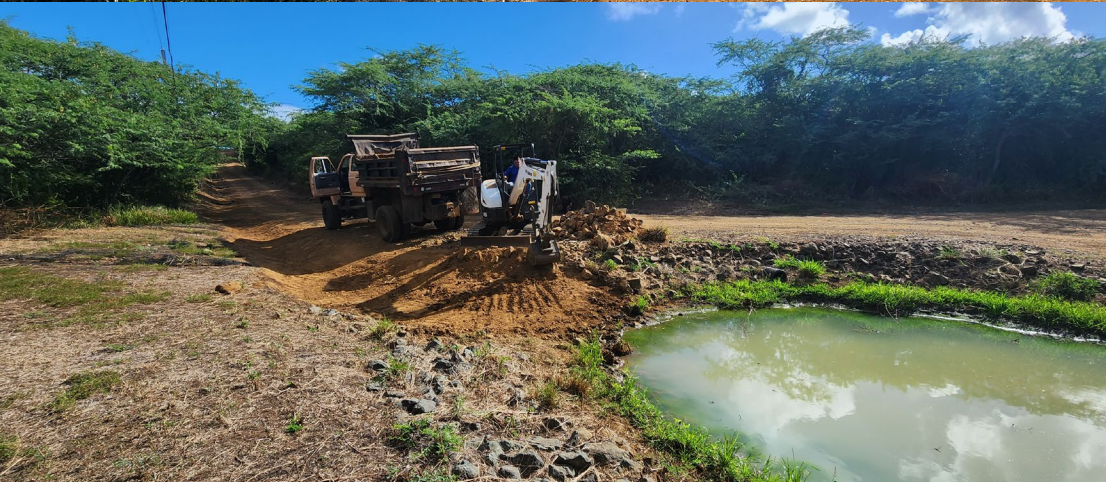
Mantenimiento y monitoreo de proyectos de estabilización de caminos de tierra

The delivery of nearly 400 cubic meters of sediment to the sea has been avoided in the last 2 years

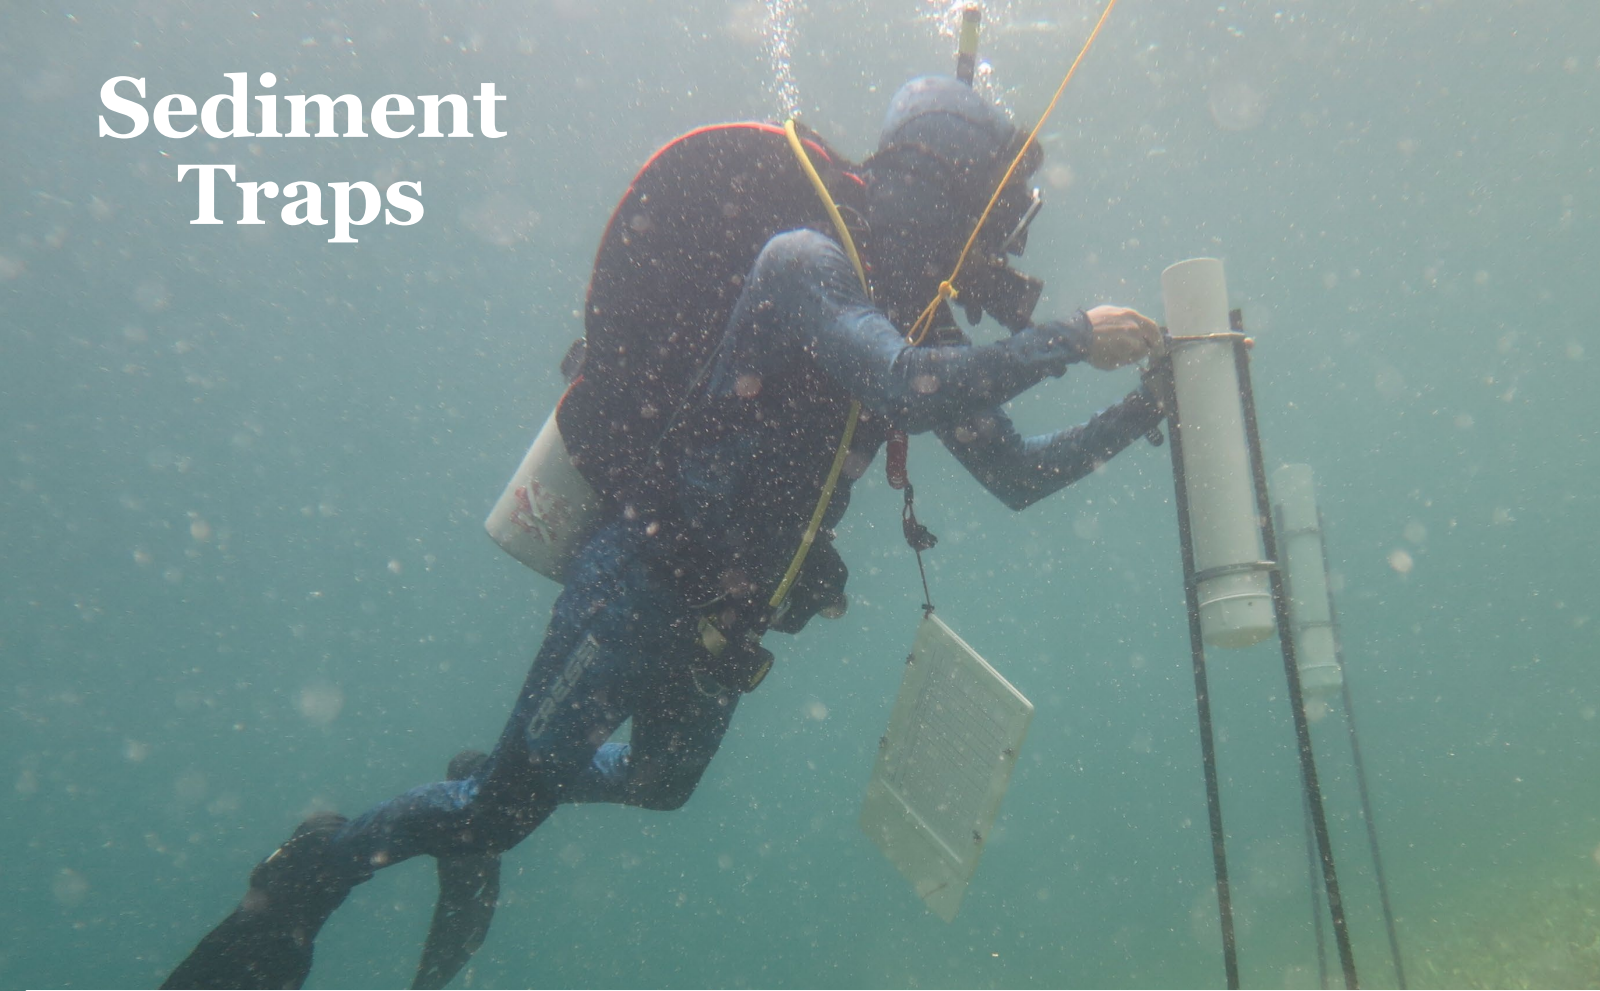
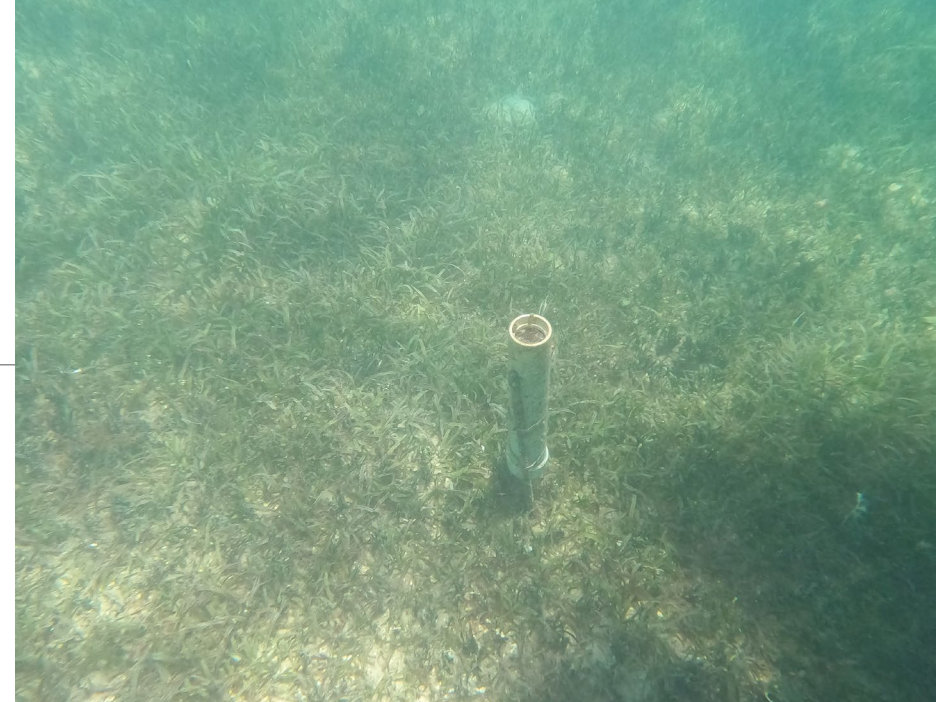
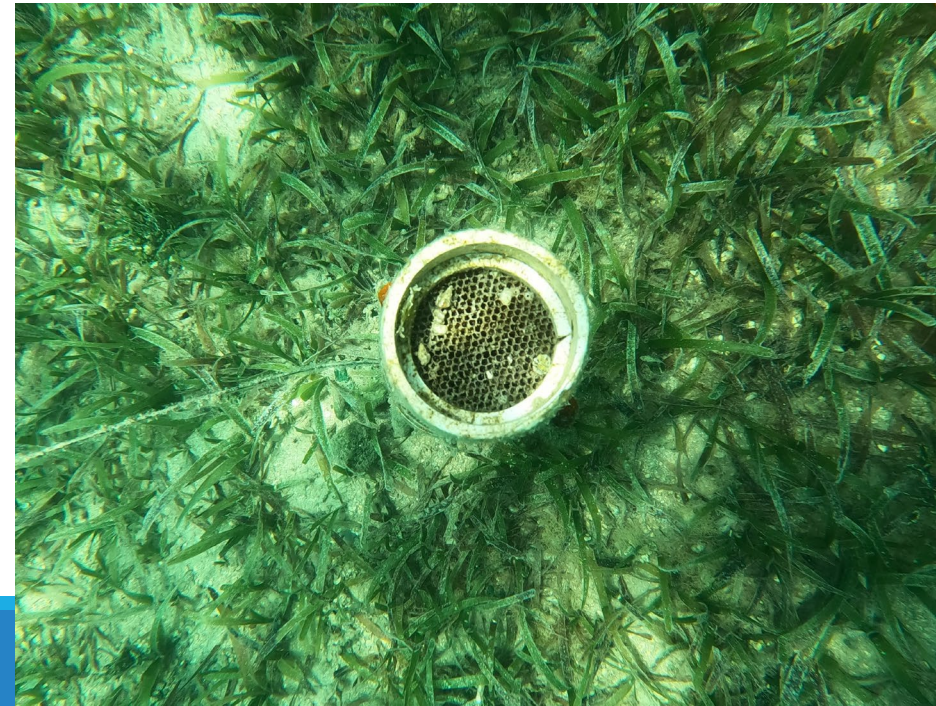
Sediment Traps

- A total of 26 sediment traps were installed in 13 monitoring fixed station.
 - Sediment traps were installed at ~10 feet depth.
 - Sediment traps are monitored every 3 months.
- Will provide data on sediment delivery rate and composition.

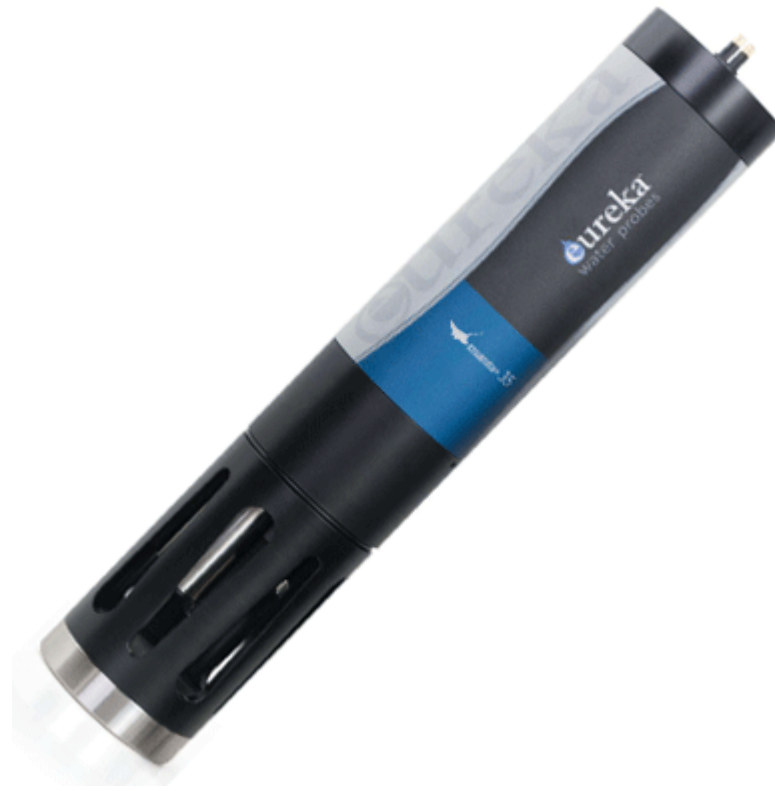
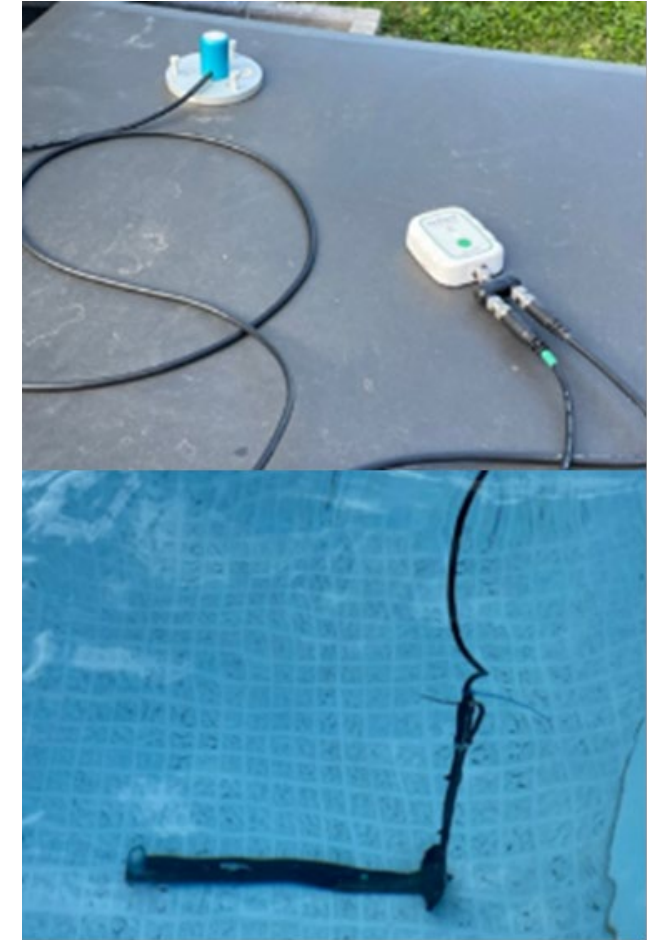
Figure 4: APOGEE PAR sensors

- Measurements are done with a Eureka Manta+35 multi-sonde probe sonde at 1-m and 2-m depth.
- Photosynthetically available radiation is measured using an Apogee PAR sensor.
- Water samples are collected to measure enterococci levels, nutrients and tracers (i.e. caffeine and sucralose).
- Nutrient and tracers analyses is being carried out by NOAA's NCCOS.

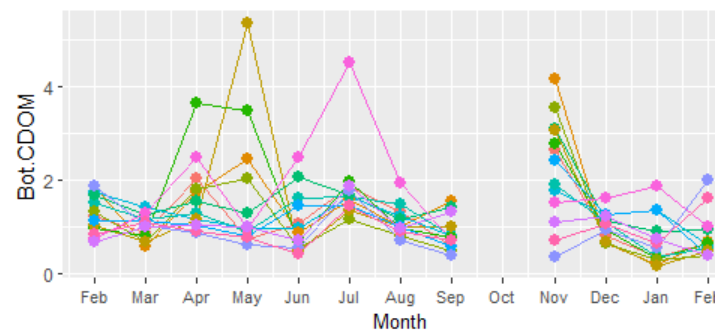
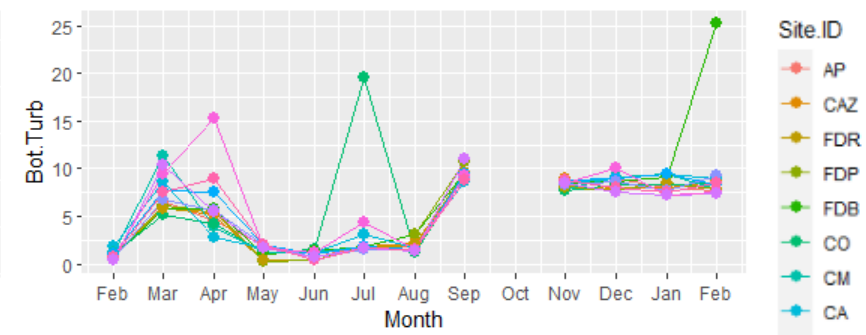
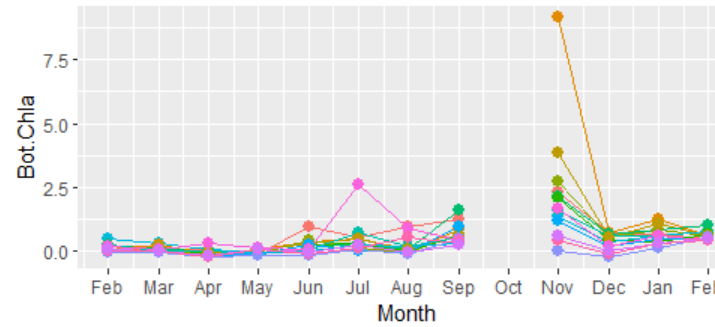
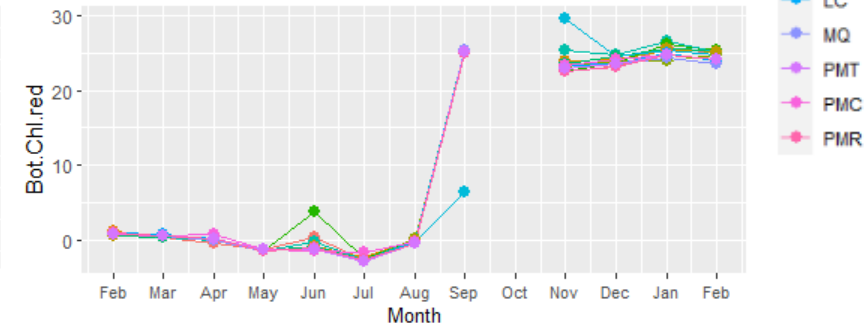
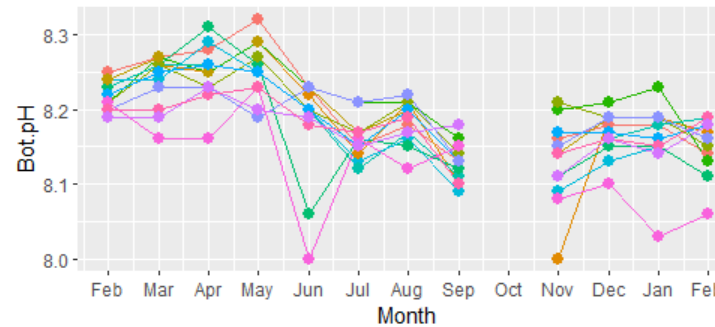
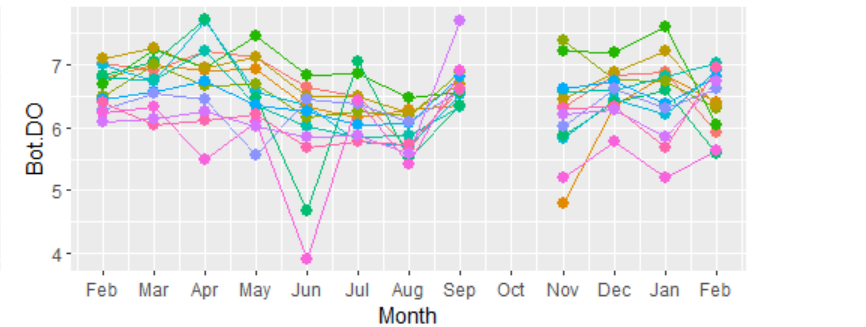
Preliminary Nearshore Water Quality Data

- Strong correlation between 1-m and 2-m depth measurements.
- Time series show variability along time for most parameters.
- This trend maybe related to changes in rainfall.

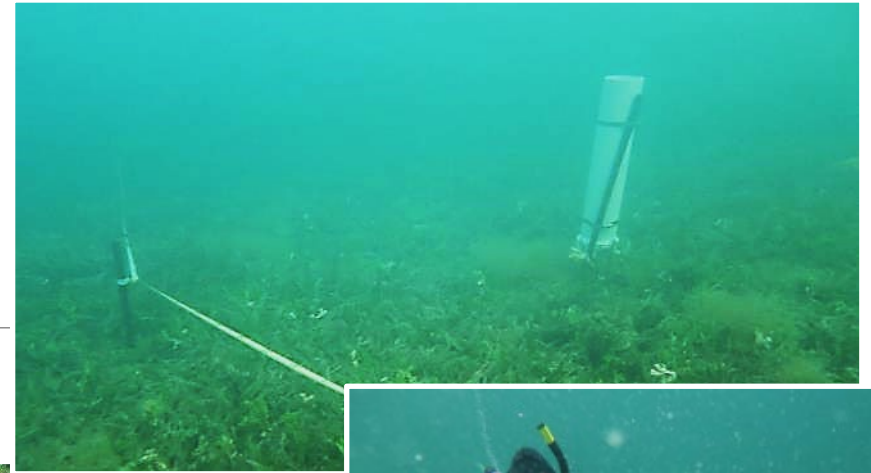
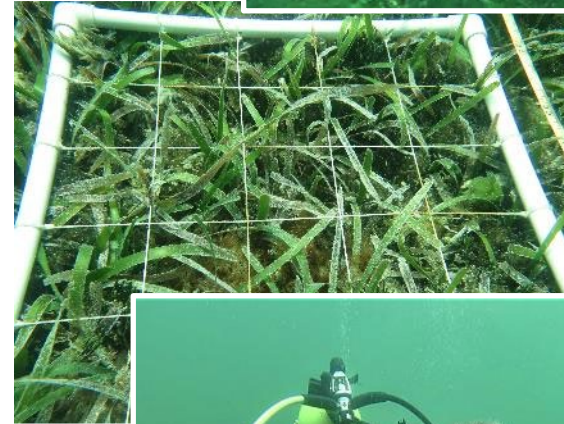
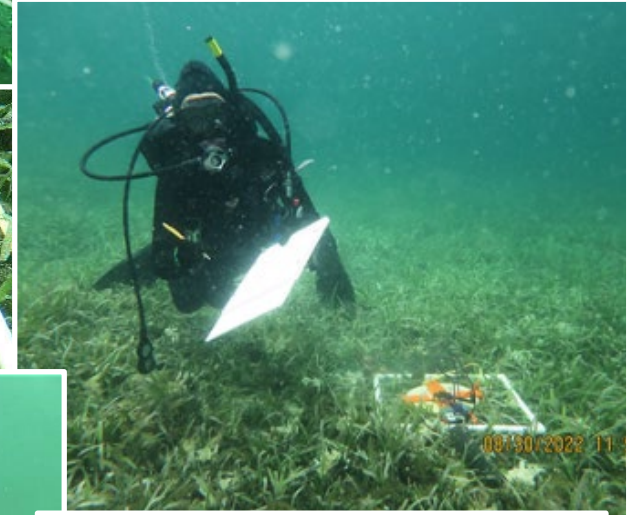
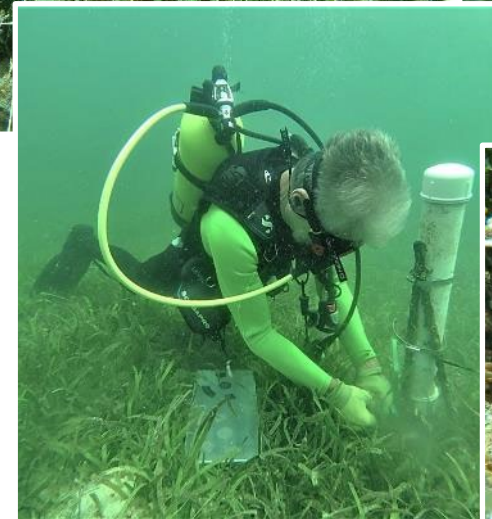
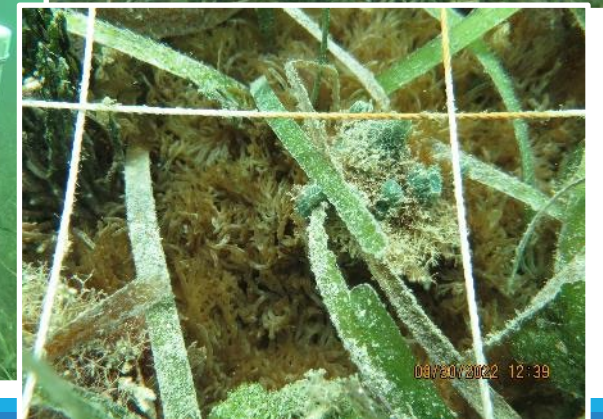
Sea grass monitoring

- Data from 2014 and 2022.
- Benthic cover and demographics.
- Epiphytometers at fixed monitoring stations.
